BMP RAM FIELD OBERVATION DATASHEET - INFILTRATION FEATURE

BMP ID **WCIF0035to50** Benchmark? Y (N)

Location On College Blvd & Lucille Dr intersection & downhill

Site Info inline, 15" (sloped) to 36" (flat) perforated HDPE infiltrating swales separated by sediment traps installed with CIVph1 WQIP (NTCD #216) in 2014, catchment RWClwer2 , PLRM - IB

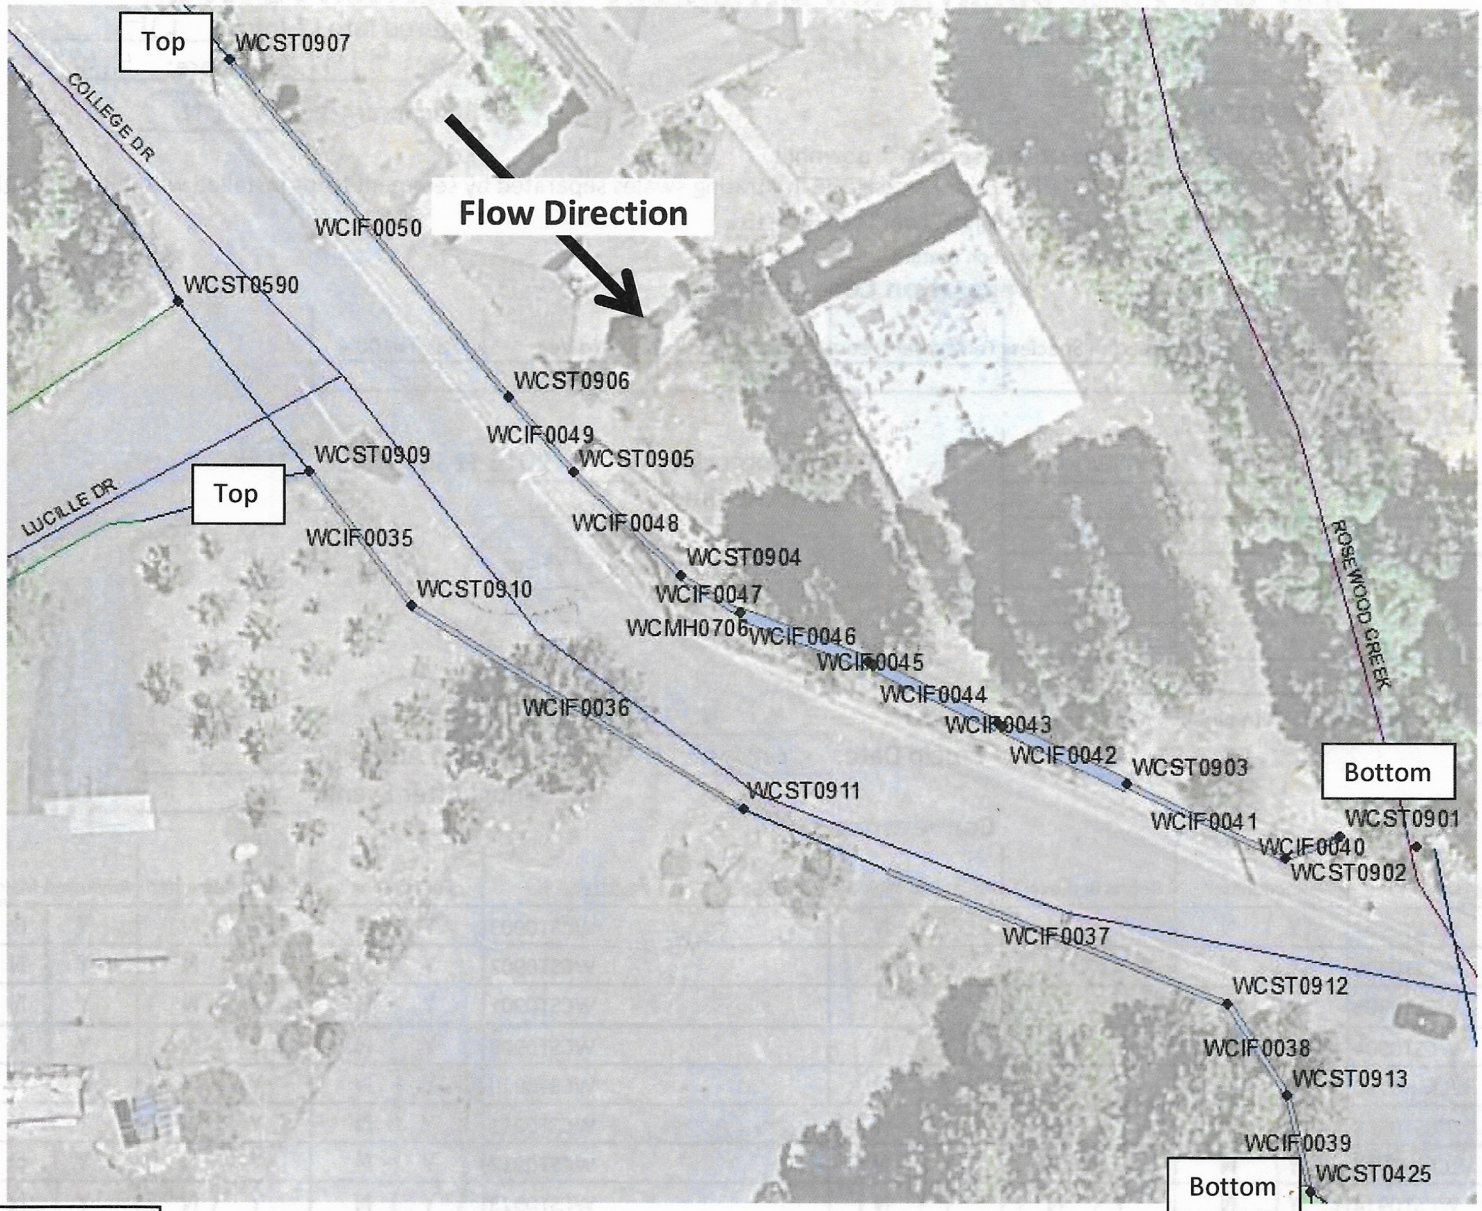
Map & Note:

Notes: damaged → WCST0903; ? rust. corrosive

Top
WCST0907
COLLEGE DR
Flow Direction
WCIF0050
WCST0590
WCST0906
WCIF0049
WCST0905
WCST0909
Top
LUCILLE DR
WCIF0048
WCIF0035
WCST0904
WCST0910
WCIF0047
WCMH0706
WCIF0046
WCIF0045
WCIF0044
WCIF0036
WCIF0043
WCIF0042
WCST0903
Bottom
WCST0911
WCIF0041
WCST0901
WCIF0040
WCST0902
ROSEWOOD CREEK
WCIF0037
WCST0912
WCIF0038
WCST0913
WCIF0039
WCST0425
Bottom
